## General Information

Property Address 1234 Example Street  
City Cincinnati State OH Zip 45200  
Contact Name  
Phone Fax

Inspector Name Maury Drummey, ASHI Certification number 10478, Kentucky Home Inspectors  
License number HI-2157  
Company Name G. C. Housing Evaluation Service, Inc.  
Company Address P.O. Box 8173  
City Cincinnati State OH Zip 45208  
Phone (513) 871-1998 Fax (513) 533-9330  
E-Mail mfd4@aol.com

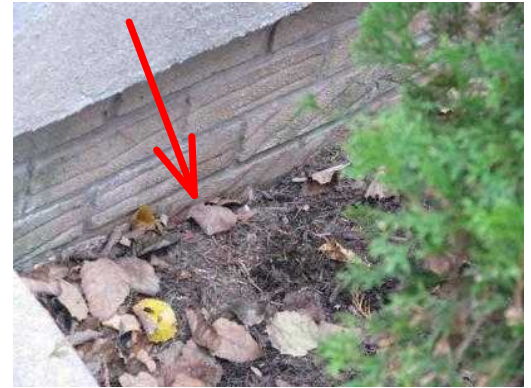
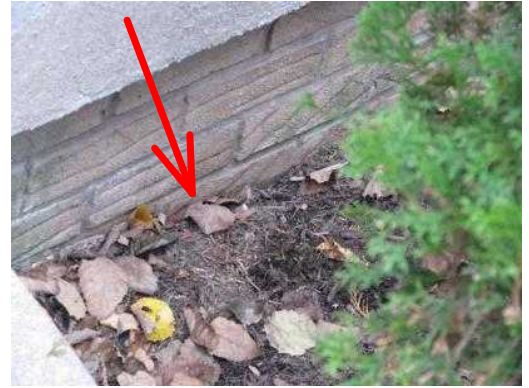
| 13. | <input type="checkbox"/> | <input type="checkbox"/> | <input type="checkbox"/> | <input type="checkbox"/> | <input checked="" type="checkbox"/> | Grading: Contact of the dirt and mulch with the brickwork must be eliminated. This contact creates a situation conducive to insect infestation and/or rot. |

1. Grading: Contact of the dirt and mulch with the brickwork must be eliminated. This contact creates a situation conducive to insect infestation and/or rot.

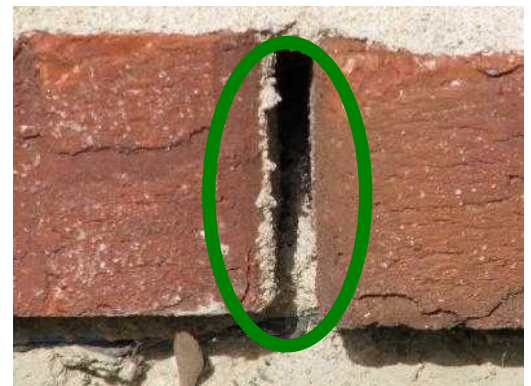
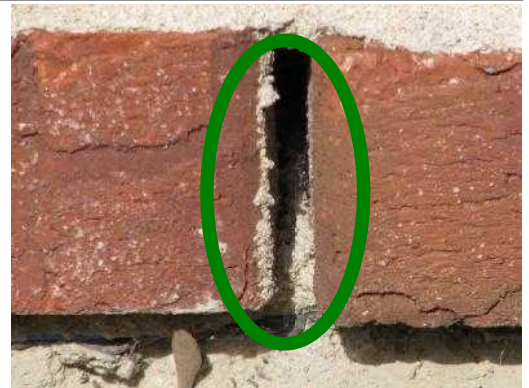
| 1. | <input type="checkbox"/> | <input type="checkbox"/> | <input type="checkbox"/> | <input type="checkbox"/> | <input checked="" type="checkbox"/> | Type: Brick veneer Obstructed (picture) and missing weep holes were noted in the brickwork. Weep holes are required in the brickwork. The weep holes should be clear and unobstructed to allow for the proper drainage of moisture behind the brick veneer. A qualified masonry contractor should make the needed repairs to the brickwork. |

2. Exterior Surface Type: Brick veneer Obstructed (picture) and missing weep holes were noted in the brickwork. Weep holes are required in the brickwork. The weep holes should be clear and unobstructed to allow for the proper drainage of moisture behind the brick veneer. A qualified masonry contractor should make the needed repairs to the brickwork.

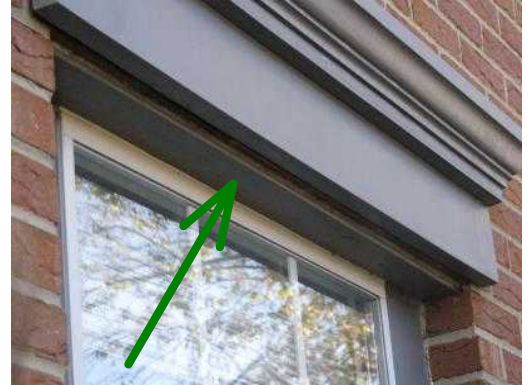
2.      **Lintels** Metal Metal lintels located above the windows and doors in the brickwork should be kept well painted. (Picture).

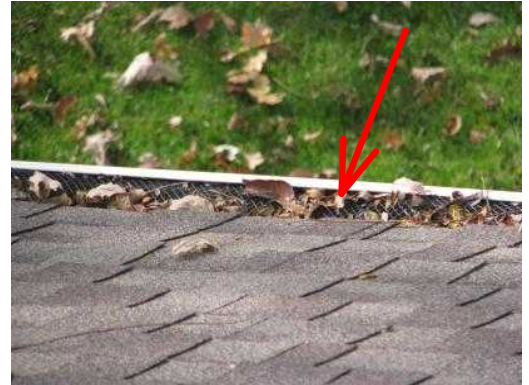
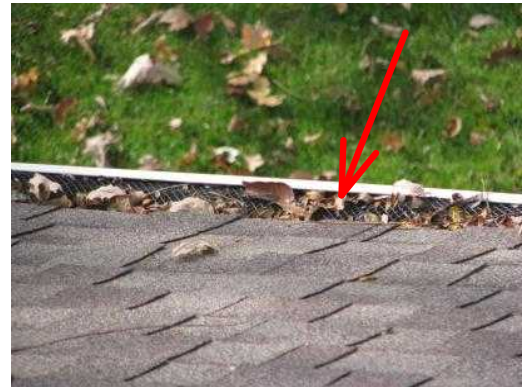
9.      Plumbing Vents:
10.      Gutters: Aluminum Leaves in the gutters require removal. (Picture). The gutters must be kept clear of leaves. Some gutters have leaf screening in place. Consideration should be given to the installation of gutter screening at all the gutters.

2. Gutters: Aluminum Leaves in the gutters require removal. (Picture). The gutters must be kept clear of leaves. Some gutters have leaf screening in place. Consideration should be given to the installation of gutter screening at all the gutters.

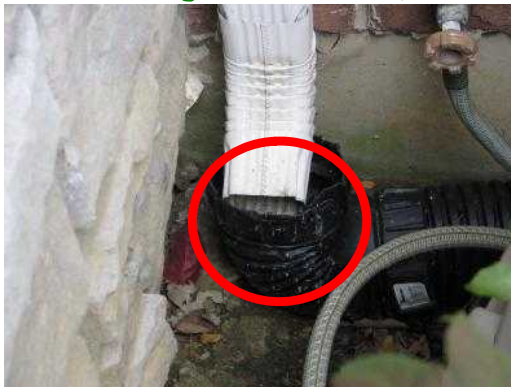
11.      Downspouts: Aluminum The northeast down spout should be extended into the drain tile. (First picture). The down spout presently dumping storm water onto the lower front roof should be extended into the lower gutter. (Second picture).

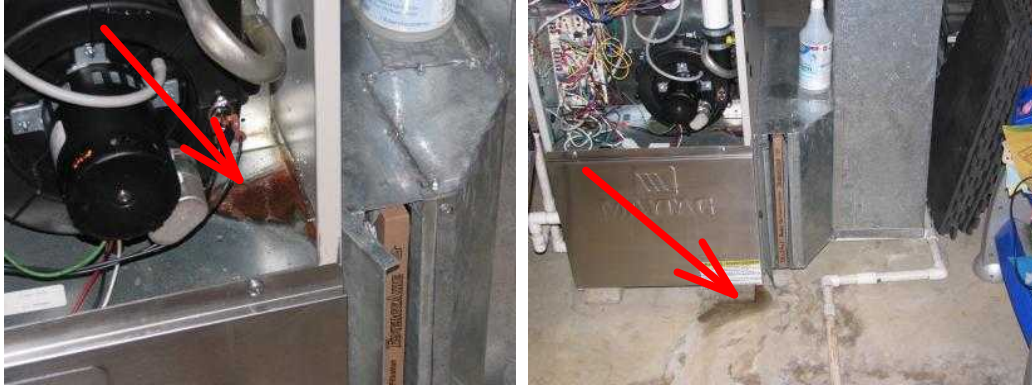
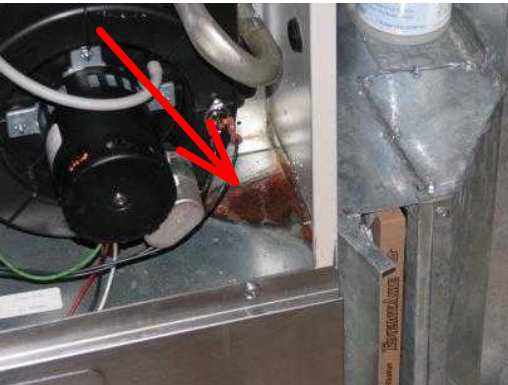
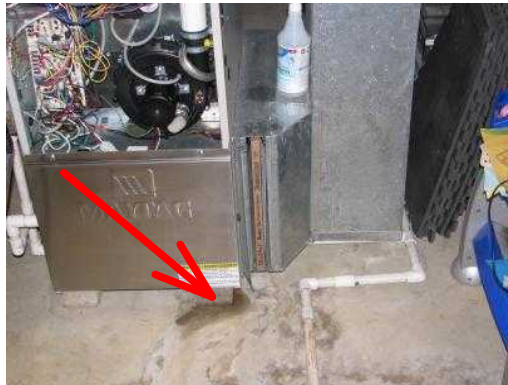
1.     Heating System Operation: Condensate leakage noted in the furnace cabinet (first picture) and below the furnace (second picture) should be eliminated by a licensed HVAC contractor.

4. Heating System Heating System Operation: Condensate leakage noted in the furnace cabinet (first picture) and below the furnace (second picture) should be eliminated by a licensed HVAC contractor.

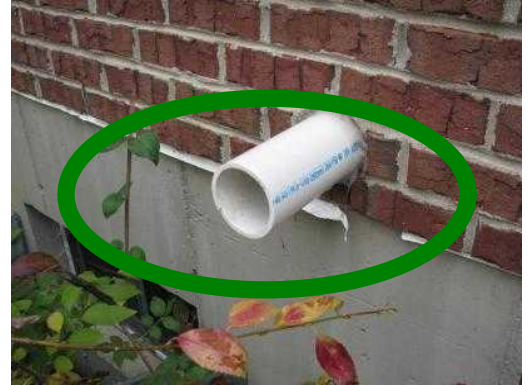
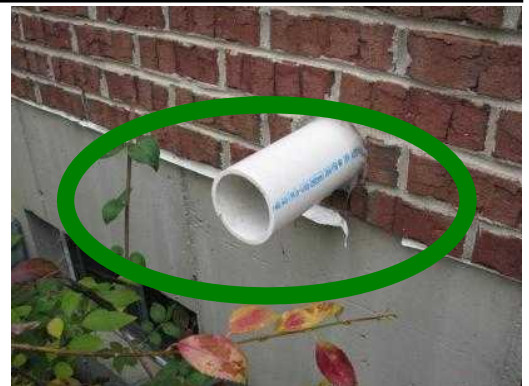
14.      Flue Pipe: PVC Induced draft The water heater three inch PVC flue pipe at the north exterior of the home should be properly terminated in compliance with the manufacturer's recommendations.

5. Water Heater Flue Pipe: PVC Induced draft The water heater three inch PVC flue pipe at the north exterior of the home should be properly terminated in compliance with the manufacturer's recommendations.

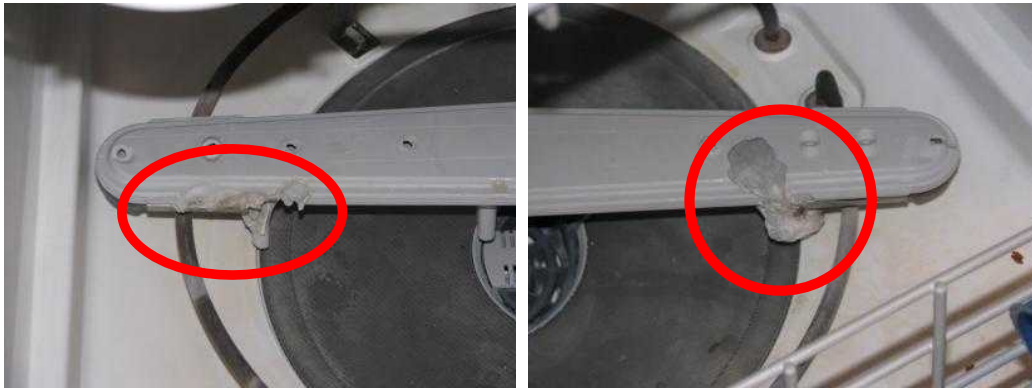
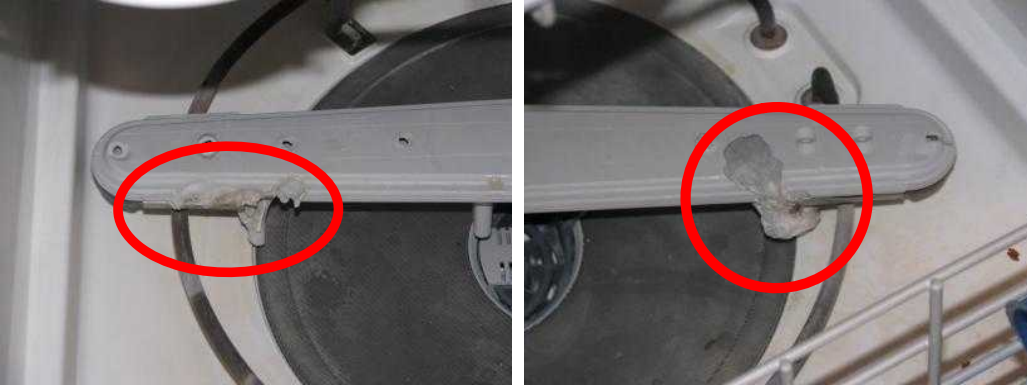
1.      Cooking Appliances: Oven/range
2.      Ventilator: Microwave The vent fan is vented into the kitchen.
3.      Disposal:
4.      Dishwasher: The dishwasher drain line should be elevated below the sink. The damaged dishwasher spray arm will require replacement by a qualified appliance repair person. (Pictures).

7. Kitchen Dishwasher: The dishwasher drain line should be elevated below the sink. The damaged dishwasher spray arm will require replacement by a qualified appliance repair person. (Pictures).

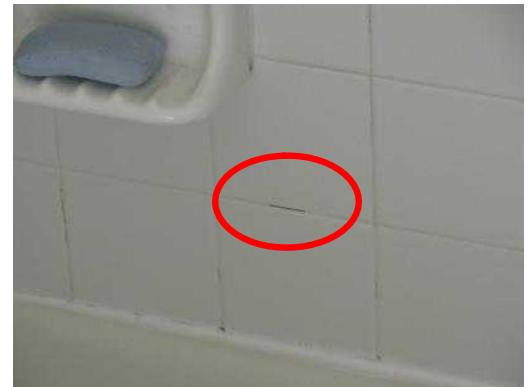
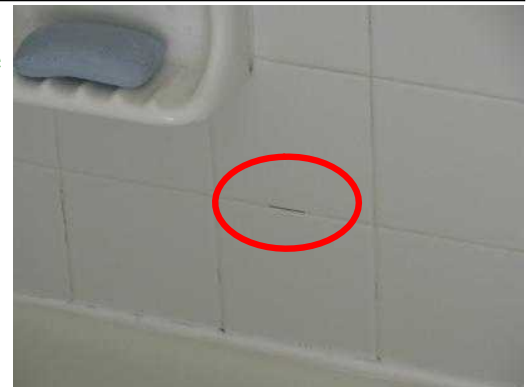
- 12.      Ceiling: Drywall
- 13.      Walls: Drywall
- 14.      Floor: Vinyl flooring
- 15.      Doors: Hollow core
- 16.      Electrical: Protected by the master bath ground fault receptacle.
- 17.      Counter/Cabinet: Vanity cabinet and top
- 18.      Faucets/Traps: The supply plumbing has shut off valves below the sink and toilet.
- 19.      Tub/Surround: Metal tub/Ceramic tile enclosure One damaged hall full bath tub enclosure grout joint, below the soap tray, requires repair.

9. Second floor hall full Bathroom Tub/Surround: Metal tub/Ceramic tile enclosure One damaged hall full bath tub enclosure grout joint, below the soap tray, requires repair.
